# Levees and Floodplain Management

**Jerry L. Rasmussen**  
**U.S. Fish & Wildlife Service**  
**P.O. Box 774**  
**Bettendorf, IA 52722-0774**

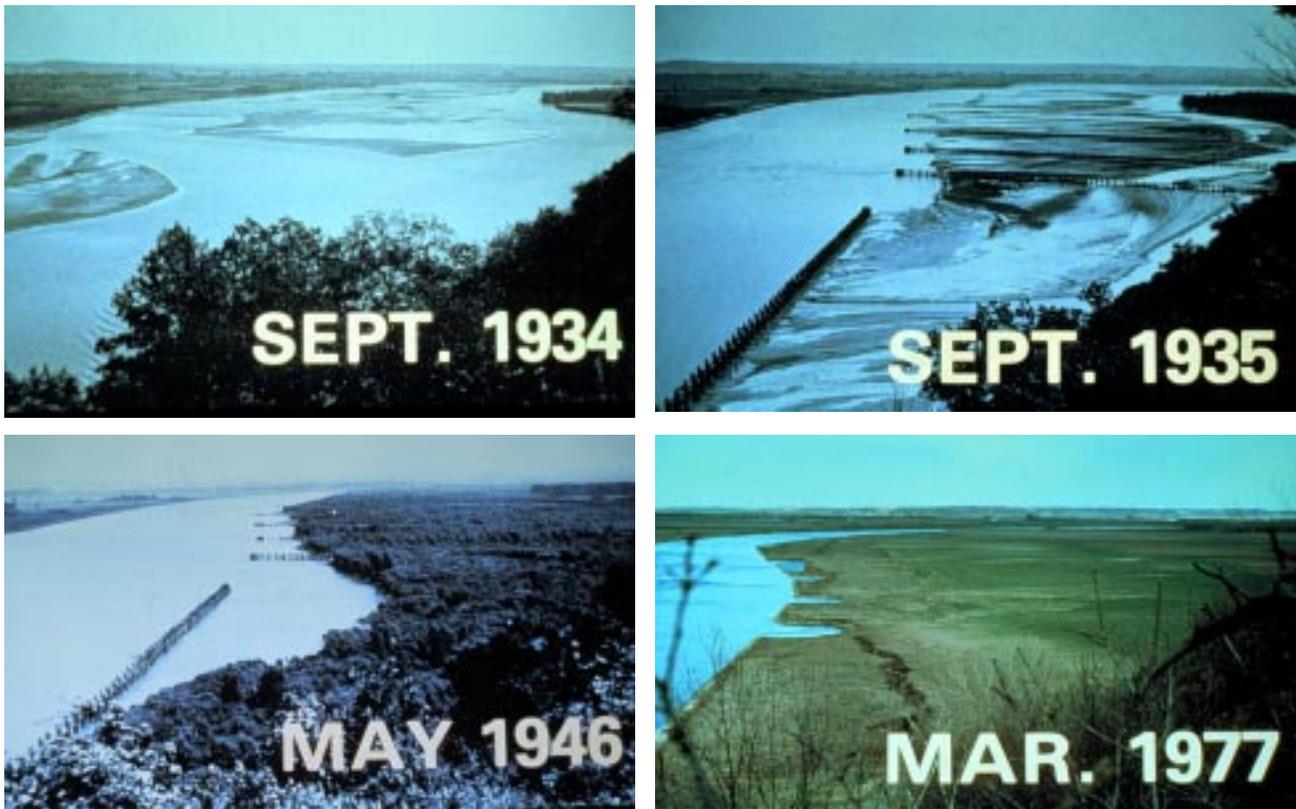
*Figure 2. Development of the lower Missouri River for commercial navigation and flood control. Photos courtesy of the Missouri Department of Conservation.*

During the first half of this century, rivers in the United States such as the lower Missouri River (Figure 2) were becoming little more than major sewer systems, seen only as mechanisms to carry away wastes, and as “common enemies” that had to be controlled, and if possible, harnessed for hydropower and navigation. In fact able bodied men were drafted, military style, to fight the river, our “common enemy” in the event of flooding. Little or no consideration was given to river ecology, to the importance of natural processes, or to man’s connection to ecological integrity. These terms weren’t even known, much less understood.

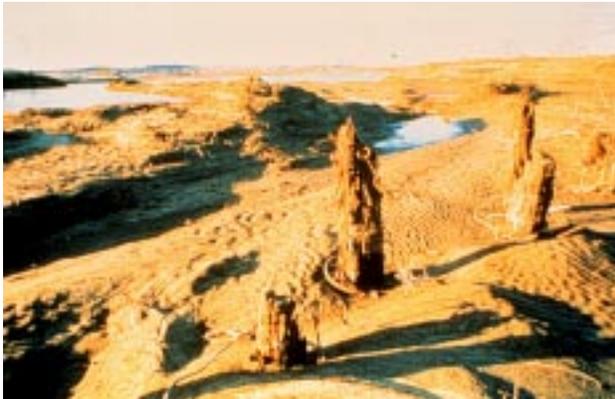
*Figure 3. Former Missouri River floodplain farmlands impacted by the 1993 floods. Photo courtesy of the Missouri Dept. of Conservation.*

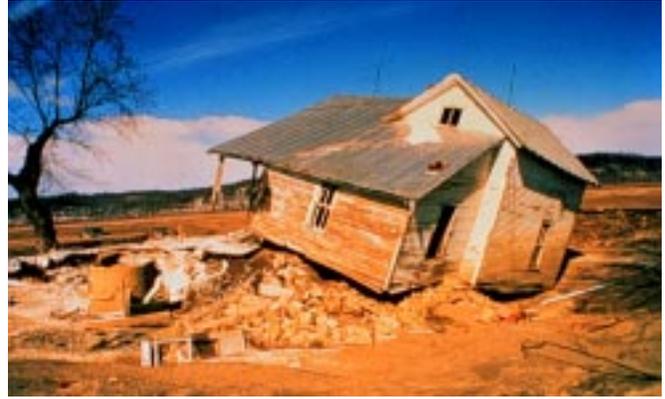
*Figure 4. Floodplain farm house destroyed by the 1993 floods. Photo courtesy of the Missouri Dept. of Conservation.*

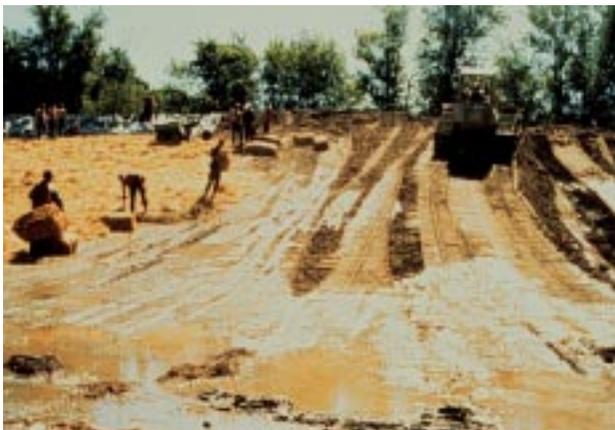
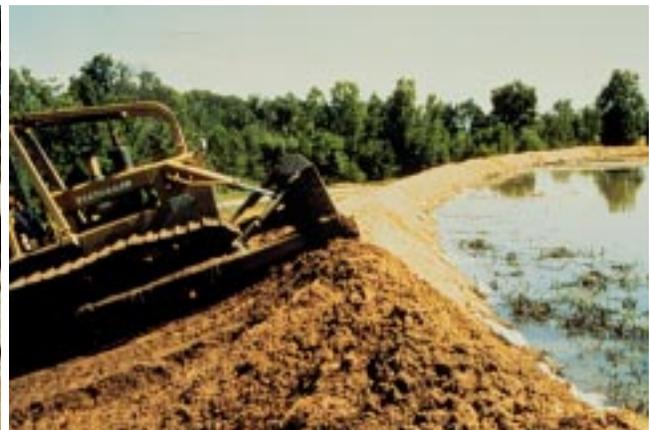
*Figure 5. The raising of this federal agricultural levee during the 1993 "flood fight" threatened neighboring lands by further constricting the floodplain and forcing flood waters to higher elevations. Photos courtesy of the U.S. Fish and Wildlife Service.*

The flood fight during the 1993 flood was largely unregulated, with each landowner or group of landowners fending for themselves. In fact some federally sponsored levees were raised as much as two feet higher than their authorized level (Figure 5). One such levee near Quincy, Illinois blocks off over 100,000 acres of floodplain, or put another way over 150 mi<sup>2</sup> of floodplain. It seemed that,

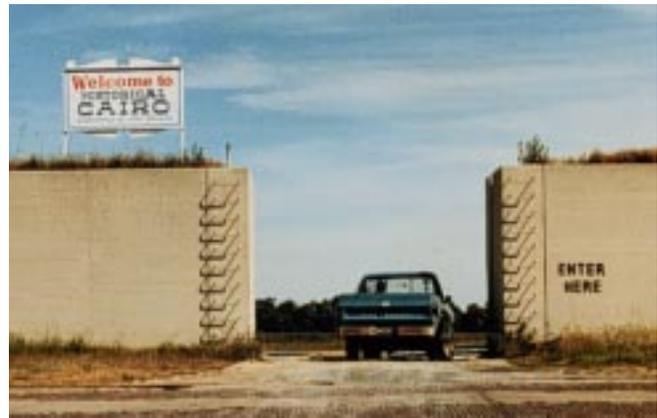
**Figure 8. The floodwall at Cairo, IL isolates the city from the Mississippi River - the very reason for its establishment in the first place.**

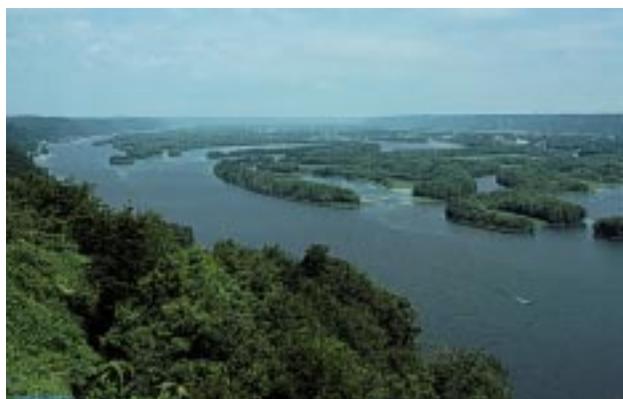
*Figure 12. View of the Upper Mississippi River floodplain overlooking Prairie du Chien, WI*

Unfortunately, a slackwater navigation project is layered over the top of that refuge. The navigation project isn’t designed to provide for flood protection, and may actually reduce it by keeping the floodplain partially inundated. But the presence of the Upper Mississippi River National Wildlife and Fish Refuge still provides flood protection by keeping the floodplain largely undeveloped and open (Figures 11 and 12).
